**THE CALIFORNIA EARTHQUAKE OF APRIL 18, 1906**

**REPORT**

**STATE EARTHQUAKE INVESTIGATION COMMISSION**

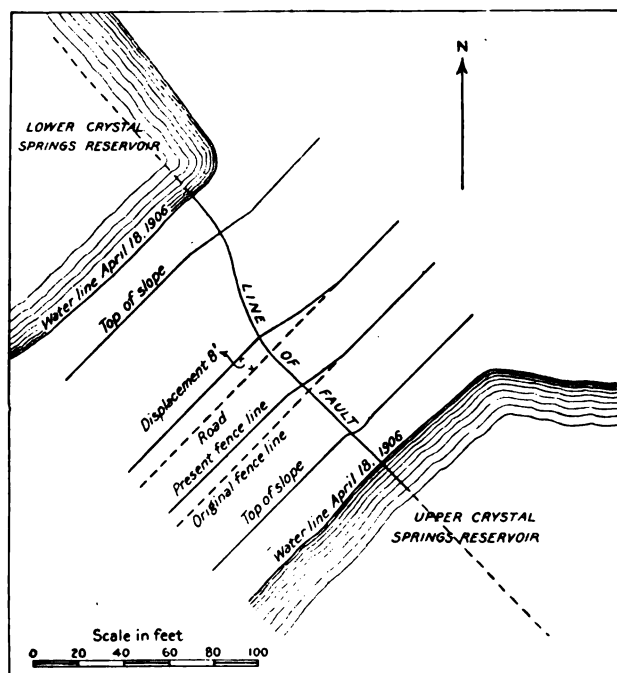
Where the fault intersects the causeway dam between Upper and Lower Crystal Springs Lakes, the dam was dislocated and offset about 8 feet. (Fig. 40.) This displacement was well marked in the roadway across the dam and in the fences which parallel it. The fences on both sides of the road were broken and the boards were buckled and shoved over each other; the telephone wires crossing the lake sagged considerably, showing that the movement brought the poles closer together. The facts indicate, as previously stated, that, in addition to the offset of the dam along the line of the fault, there was a notable compression in the direction normal to it. Beyond this dam the trace of the fault is partly beneath the lake and partly skirts its southwest shore (for the water level of April, 1906), and finally leaves the lake on that side about 0.25 mile from its southeast end.

FIG. 40. — Map of fault-trace across old dam between Upper and Lower Crystal Springs Lakes. After H. Schussler.

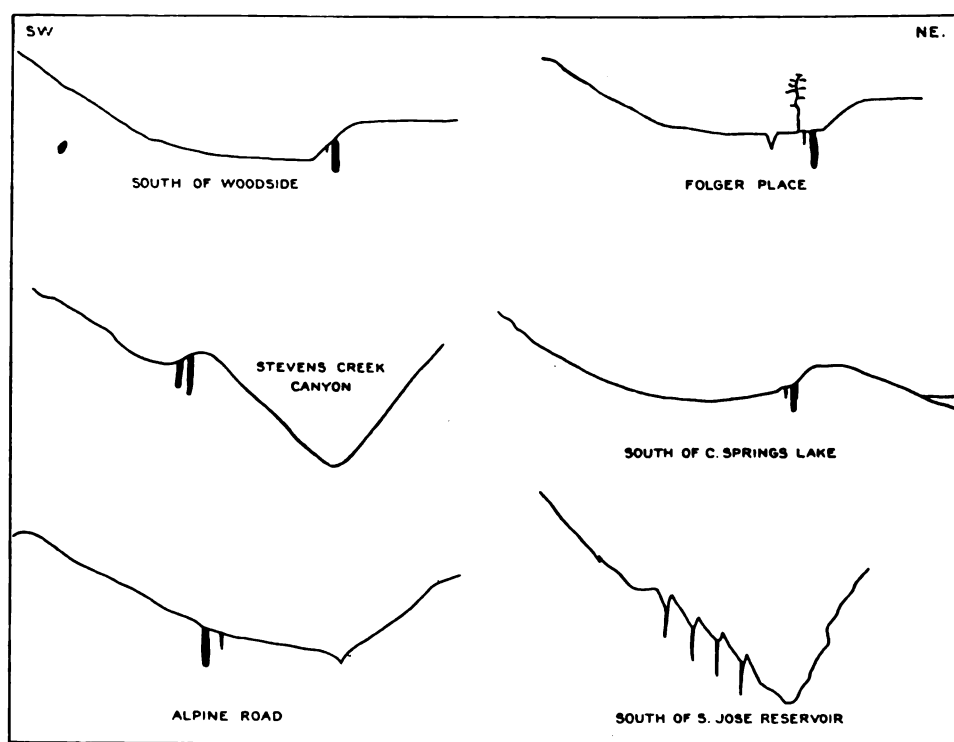
*Summary statement* (J. C. Branner). — The fault-trace that follows the San Andreas Valley continues southeastward in a nearly straight line. Beyond Crystal Springs Lake, it passes thru the village of Woodside, the Portola Valley, crosses Black Mountain a mile southwest of the triangulation station, follows down the general course of Stevens Creek a distance of 5 miles, and thence, following the same general direction along the eastern slope of Castle Rock Ridge, passes off the eastern side of the Santa Cruz quadrangle near latitude  $37^{\circ} 10'$ . West of Stanford University it follows along the northeastern base of the mountains that lie between the Pacific Ocean and the Bay of San Francisco, but as it passes toward the southeast, it cuts into the range and leaves Black Mountain and Monte Bello Ridge on the northeast side, while south of Saratoga it keeps well within the mountains. A singular feature of the fault, as it appears at the surface, is that instead of following the bottoms of the valleys, it often skirts along the base of one of the enclosing ridges, as shown in the accompanying sections. (Fig. 41.) This is not an invariable rule, however.

FIG. 41. — Profiles of Rift, showing relation of fault to slopes.

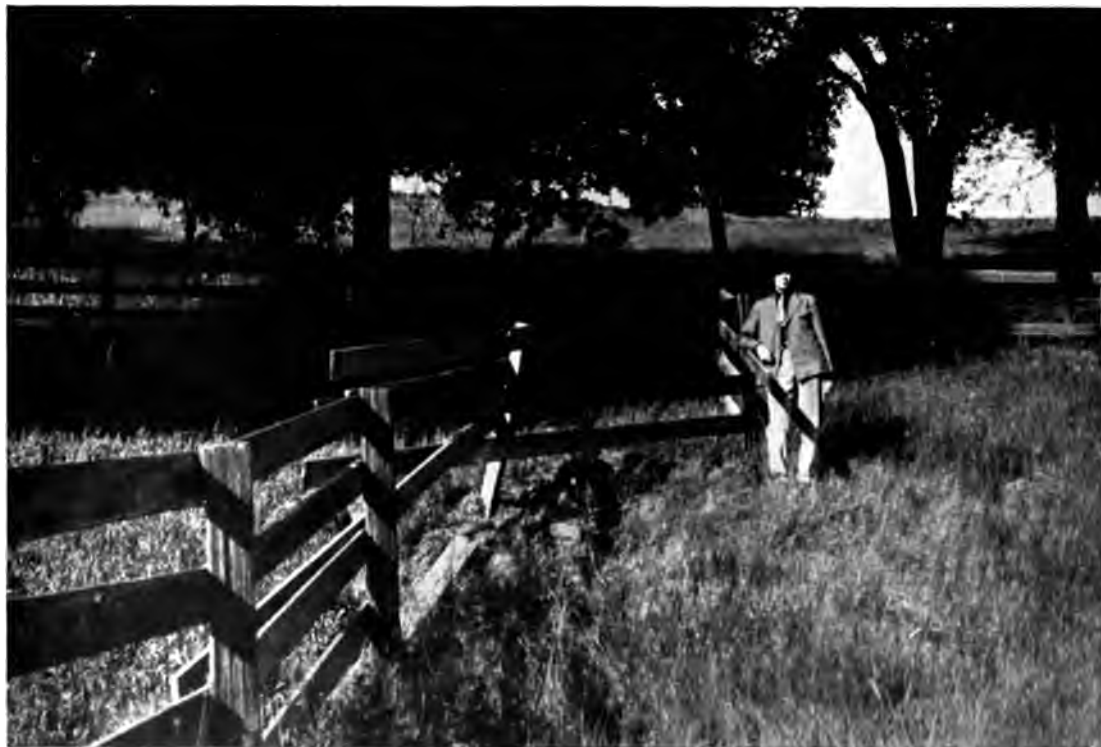
B. Offset of 8 feet in fence on Folger ranch, near Woodville. Per J. C. B.

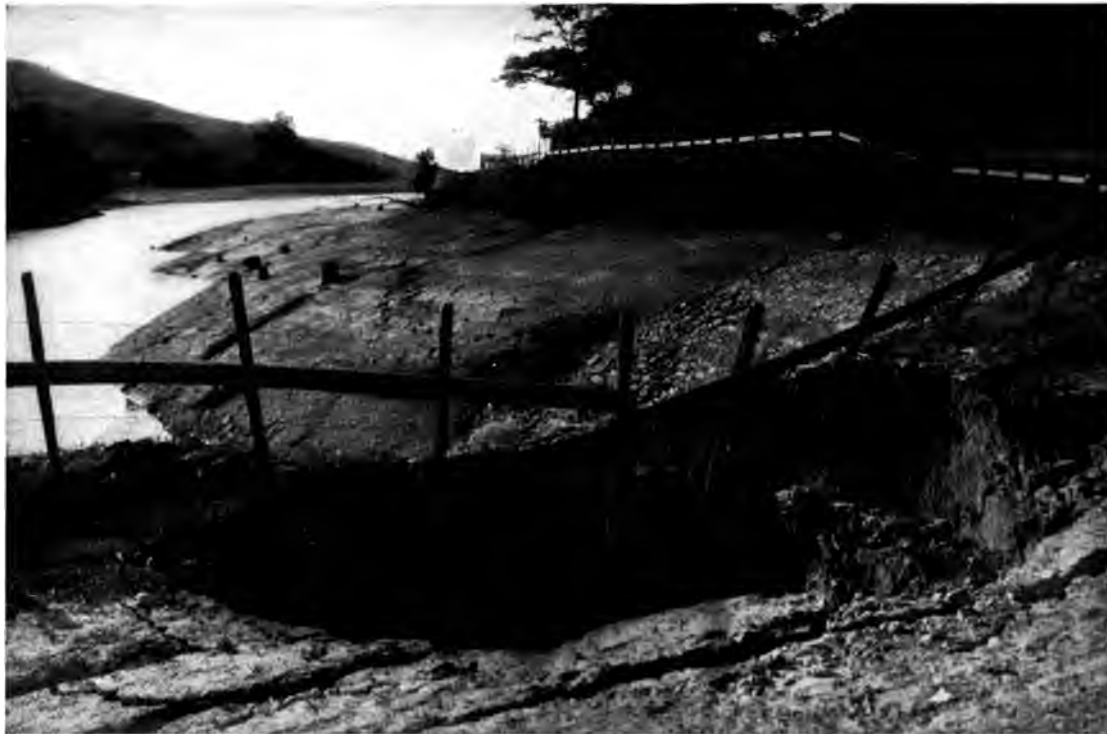
*South of Congress Springs.* — Near and northwest of the reservoir 2.5 miles southeast of Congress Springs, fissures from 4 to 6 feet wide ran nearly north and south, and past thru the earthen dam at the northwest end of the reservoir. (Plate 64A.) The intake pipes at the south end of the reservoir were disconnected, and the escaping water undermined a part of the southern dam of the reservoir. This reservoir is in a topographic saddle and has dams at both ends. The fault-trace passes thru this saddle. Where the bottom of the reservoir was exposed by the escape of the water, cracks of the fault-trace were exposed in the mud. Fences crossing the fissures showed but little displacement; the displacement moved the northeast side toward the southeast, relatively. The hills southeast of the reservoir have steep slopes of from 20 to 50 degrees. The cracks follow the east-facing slopes and the east side of these cracks had raised about 6 or 8 inches. Southeast of the reservoir the chimneys and water-tanks were down.

A. Reservoir in saddle south of Saratoga traversed by main fault. D.

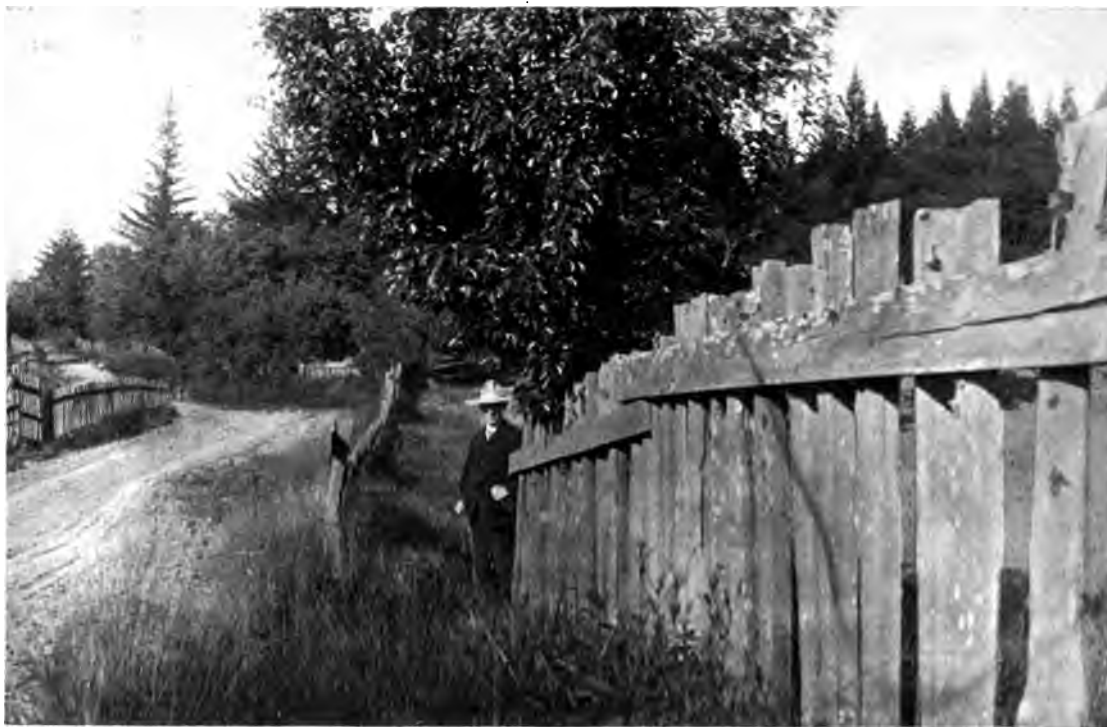
cracks alternating with a few long, continuous fissures, mark the course from Patchin to Wright Station. Thru the Morrell ranch it is especially evident. (See plate 64B.) At Wright Station the movement is well shown in the railway tunnel. (Fig. 42.) This tunnel runs southwest, and about 400 feet in from the eastern end of it there is a nearly vertical slicken-sided plane, showing a shear movement of 5 feet. Apparently the southwest side moved northwestward. Between Wright and Alma, the railway track was badly bent in places (see plate 107A), but the ground did not crack noticeably. It seems to have been subjected to compression, for 7 inches had to be cut from the rails when the track was repaired. A large landslide also occurred close to Wright Station, partly damming up the stream. The fault past a little west of Wright, tearing up the public road at several places (plate 65A), especially at the blacksmith shop, near Burrell-School-house. Sulfurous fumes are said to have risen from this crack for several hours. From this place the cracks run up over the ridge just west of Skyland. Large fissures show in the orchards and fields on the eastern side of the ridge, but are not so evident on the western slope. Here, instead, great landslides occurred, and redwoods were snapped off or uprooted. Thru the timbered region from Skyland to Aptos Creek, the course of the fault-trace is marked almost its entire length by a swath of felled trees, true fault fissures being found at only two places. On the northern side of Bridge Creek Canyon there are typical cracks from 1 to 8 inches wide, and here also occurred a great landslide which buried the Loma Prieta Mill. The second place where fault fractures are found is on the ridge between Bridge and Aptos Creeks, where there are well-defined fissures up to 18 inches in width, trending S. 3° E., with a downthrow of the western (upper) side of from 2 to 6 feet, and a relative movement of the east side a few inches toward the south. The cracked zone is about 50 feet wide. Great slides on both sides of Aptos Creek have almost made a valley of the canyon for fully 0.75 mile. Following across the ridges and canyons, the discontinuous line of slides and sinks in upland marshy places marks the course of the fault-line down into the lowland.

B. Offset in fence at Morrell's ranch, above tunnel at Wright station. This particular displacement was not found in tunnel. G. A. W.

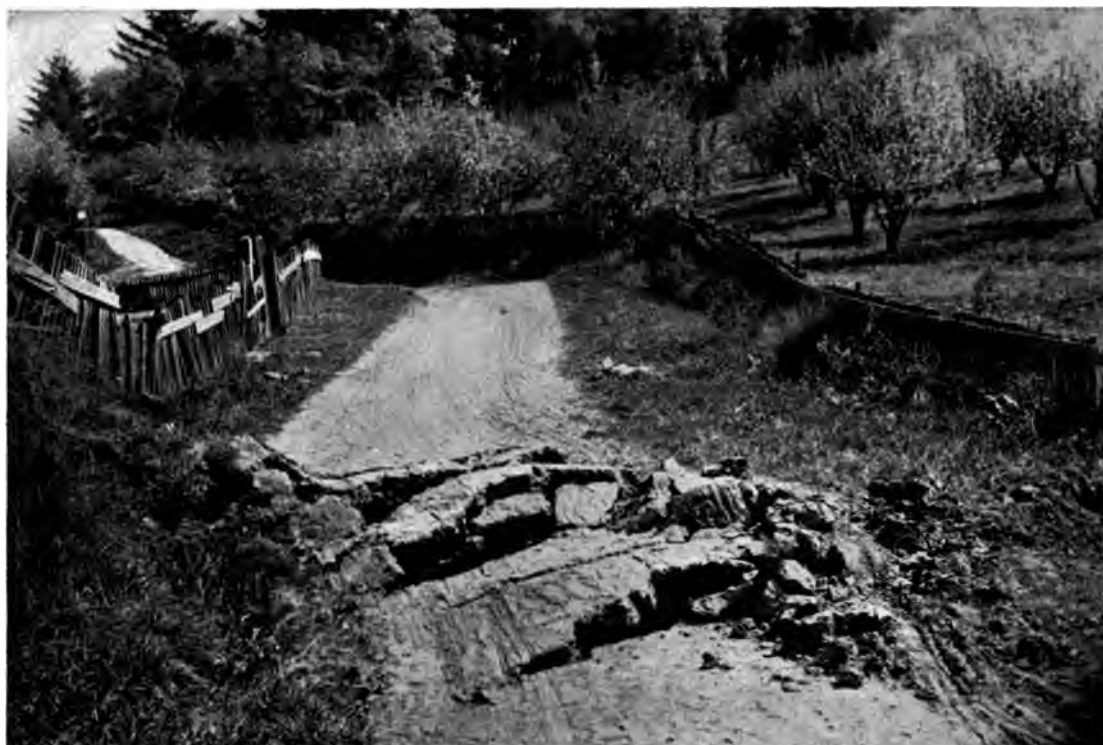
A. Offset in road near Wright. G. A. W.

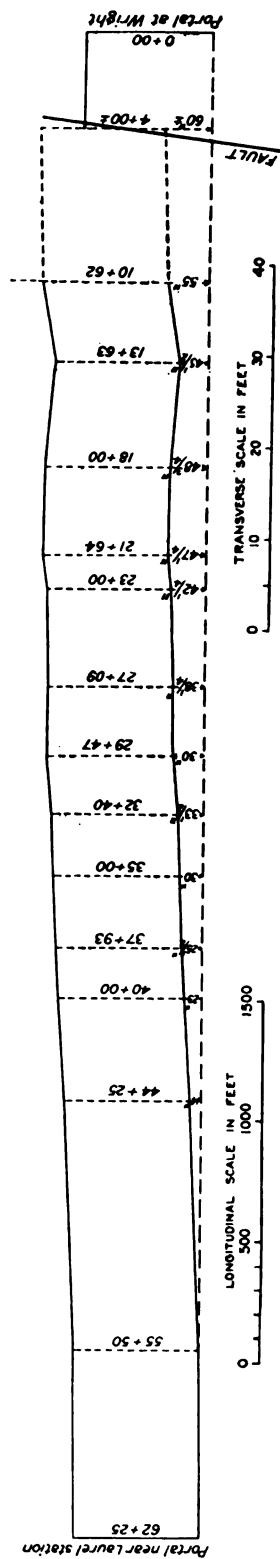
I examined with particular care the walls of the tunnel at several points where the damage to the timbers appeared to be greatest, more especially between 1,400 feet and 2,200 feet in from the opening at Wright. At each place I found several fissure lines running somewhat irregularly, but in general parallel to the fissure already described 400 feet in from the entrance at Wright. These fissures all contained more or less attrition material. Three of them I had an opportunity to examine better than the others. In each case two distinct sets of striae were found, one set vertical and the other set horizontal. The horizontal set was clearly more recent than the vertical set, and to all appearances might have been formed the day before. The three slicken-sided faults mentioned were the only ones that looked as if recent movement had occurred. The rocks in the tunnel look like sandstones and jaspers of Franciscan age. According to the evidence, so far as it went, the whole of the top of the mountain is fissured thruout in such a way that a large movement could be distributed among several fissures and thus account for a relatively slight motion along any one fissure. The measuring of any minor movements in the tunnel would be difficult because of the caving in of the rocks at such points. It would seem, too, that such movement could occur without materially altering the line of the tunnel at that point, so far as the timbering is concerned.

As far as learned no recognized fissures or faults have been crossed by the workmen thus far, except the one 400 feet from the northeast portal. Nothing corresponding to the fissure passing Morrell's house has yet been found in the tunnel.

FIG. 42.—Tunnel at Wright Station, showing distribution of deformation.

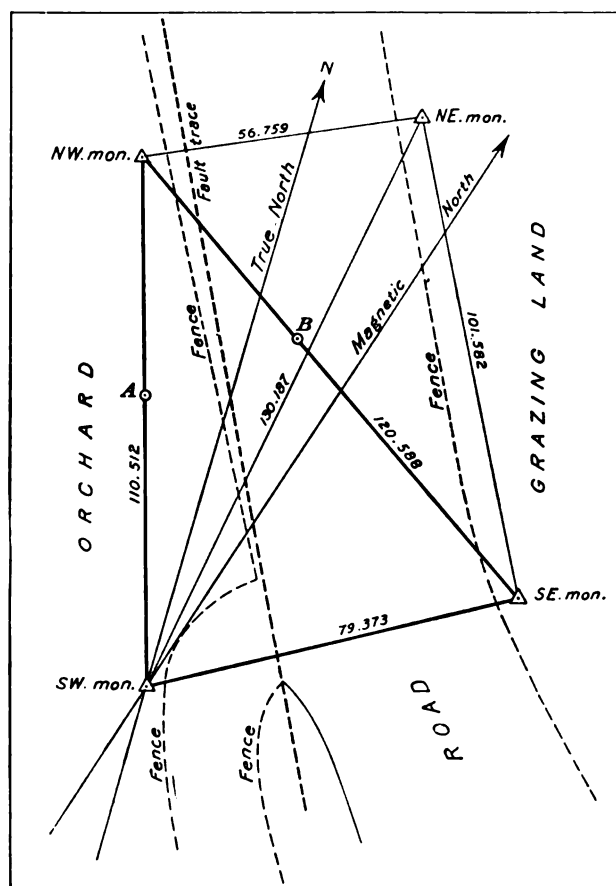
FIG. 44. — Monuments at Olema.

The relative positions of the four monuments are shown in the diagram, fig. 44. The lengths of the three heavy lines were determined by measurement. The measurements of the other three lines were considered impracticable, on account of the great height of the northeast monument above the others, as compared with the short distances between them and it. By means of the three measured lines, however, a double determination is obtained, thru the observed angles, of each of the three lines not measured by the steel tape.

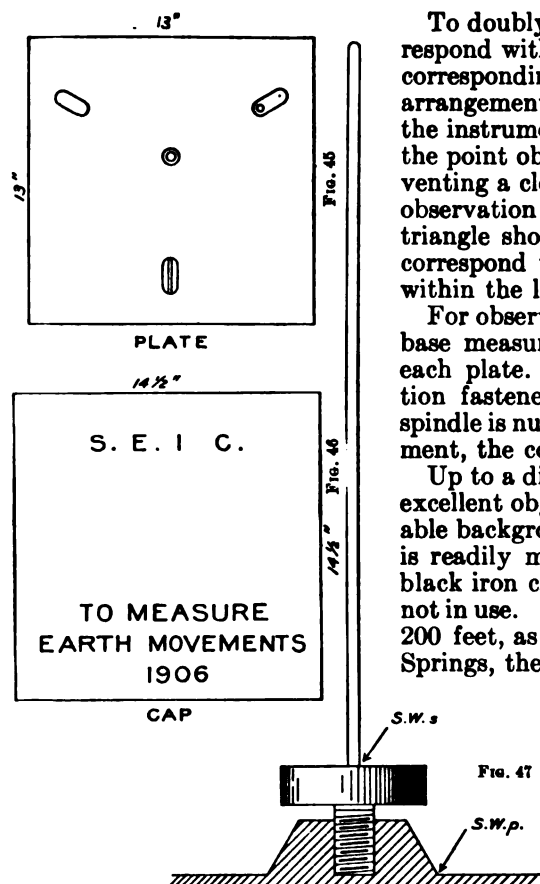
FIG. 45. — Diagram of bronze plate on monuments.

A sketch of the plate is shown in fig. 45. The spindle which screws into the central socket of the plate is shown in fig. 47, and the iron cap which protects the plate when the spindle is removed is shown in fig. 46. Referring to the sketch of the plate, it will be seen that there are three lugs, or foot-plates, standing upon and attached to it. In one is a groove (vertex of angle at bottom), and in one a hole (inverted cone), while the third has simply a smooth surface. This arrangement prevents any binding of the foot-screws of the instrument, and insures that it will always be set in the same position in successive measurements.

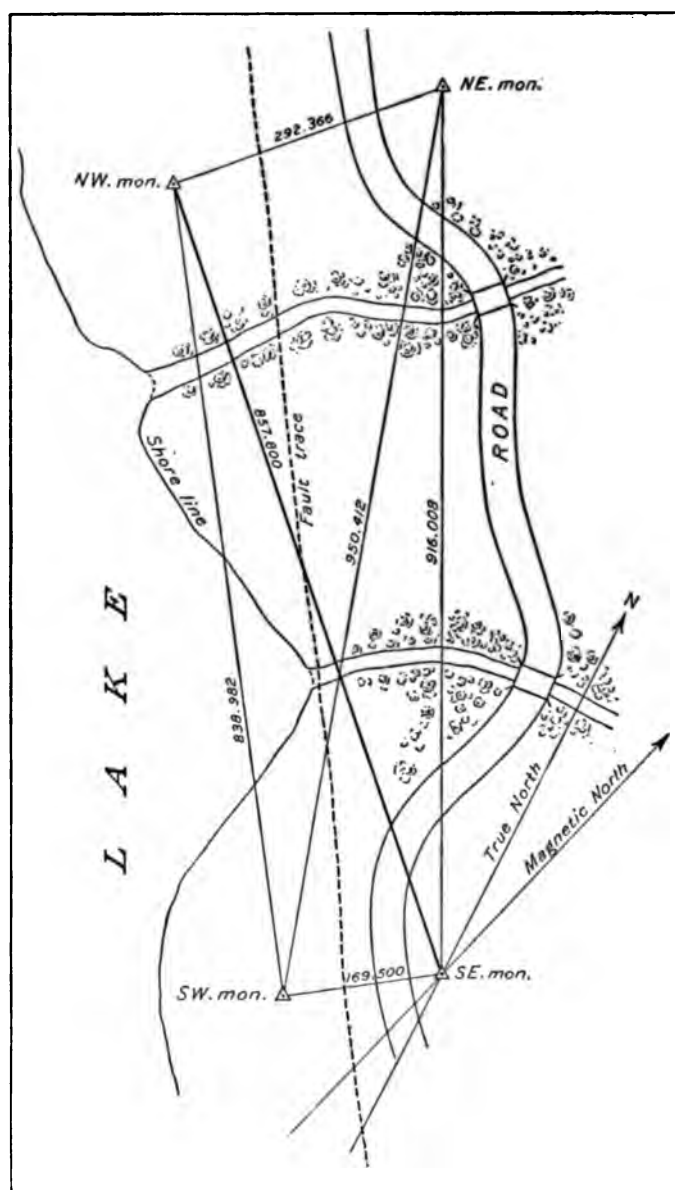
FIG. 48. — Monuments at Crystal Springs Lake.

As will be seen from the leveling record, and from the accompanying rough sketch, fig. 48, the ground is very uneven, and the measurement of a base-line was executed under considerable difficulty. The line measured, which was the only practicable one, crosses two ravines and comes up toward the southeast monument, over a very steep road embankment. Considerable clearing of brush was necessary in order to cross the ravine near the northwest monument. On account of the large differences of level between the base-line stakes in some places, the leveling had to be done with extreme care, there being at one place a rise of 11.5 feet in 50 feet, and, next to the road embankment, a rise of about 6 feet in 20 feet.

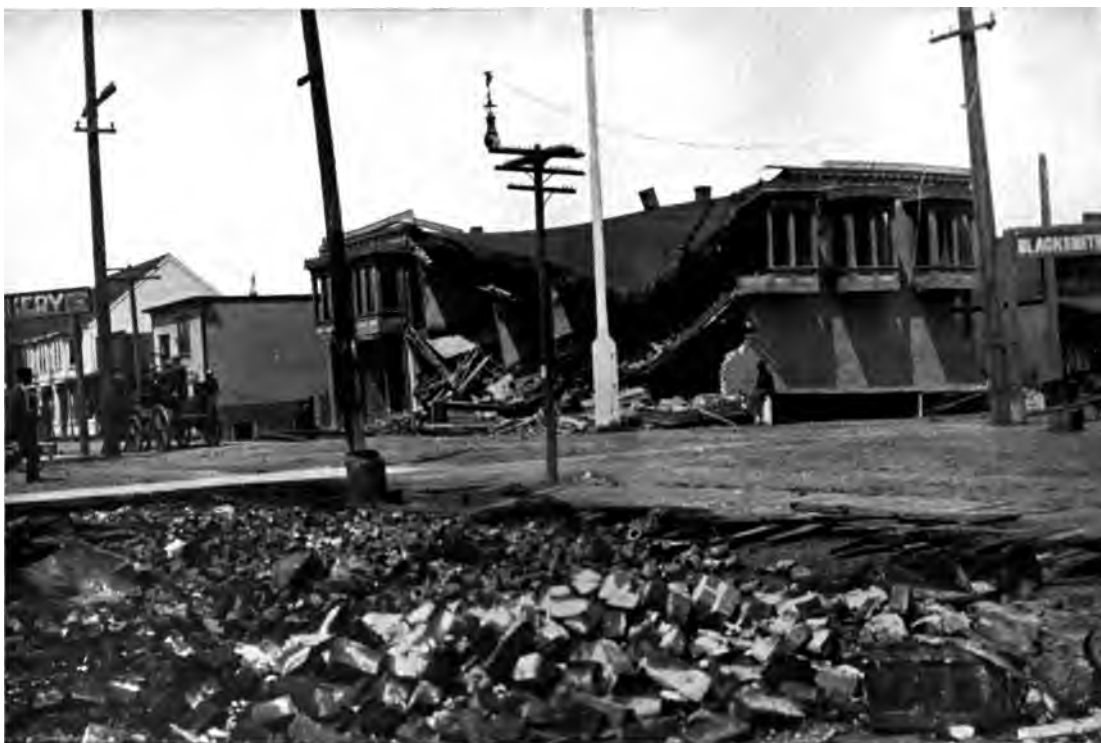
B. Wrecked buildings, Fort Bragg. Looking northwest.

*Fort Bragg, Mendocino County.* Population 1,600. (F. E. Matthes.) — The town of Fort Bragg suffered quite severely, and the indications are that the intensity of the shock was considerably greater than in the towns immediately to the south. Several brick buildings were completely demolished; others had parts of their walls broken off. Even a number of wooden buildings collapsed or were partly wrecked. Fire broke out and devastated  $1\frac{1}{2}$  blocks before it could be controlled. The water mains were disconnected and the entire town might have been wiped out but for the timely assistance of the steamer *Higgins* in the harbor. The mill lost its iron smoke-stack, and was temporarily crippled. In all, the damage thru fire and earthquake is estimated at \$100,000. (See plates 66B and 67A, B.)

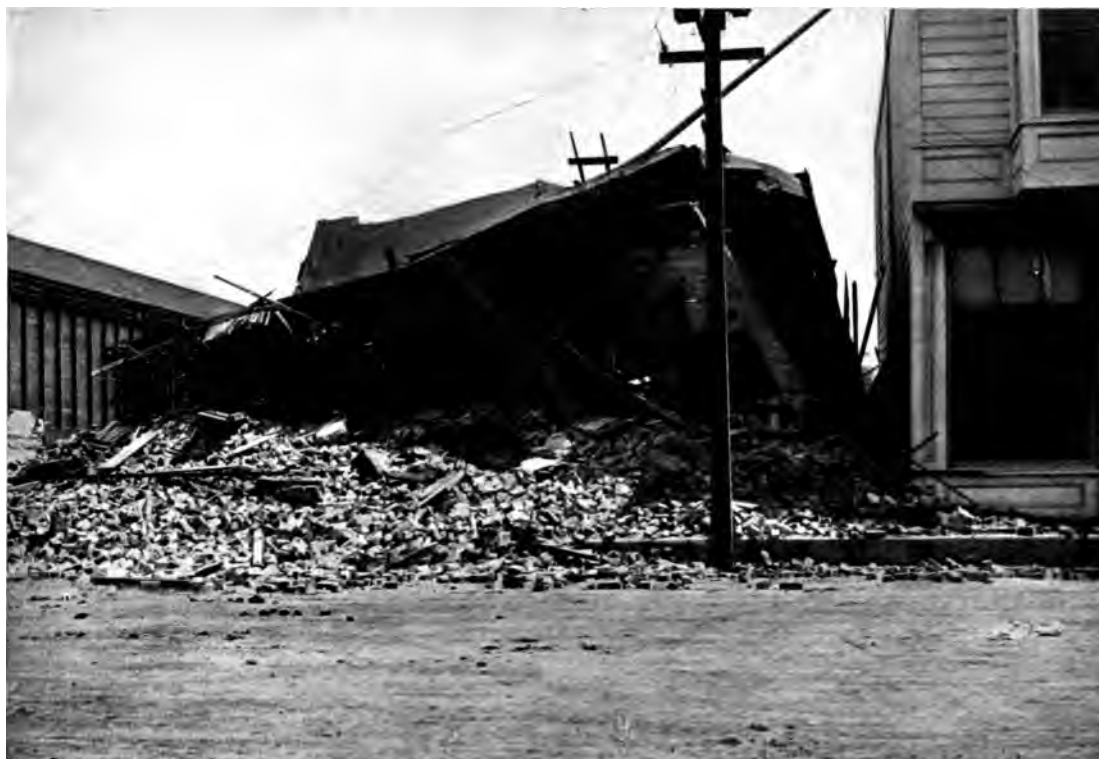
A. Odd Fellows' Hall, a 3-story brick building. Fort Bragg. Looking east.

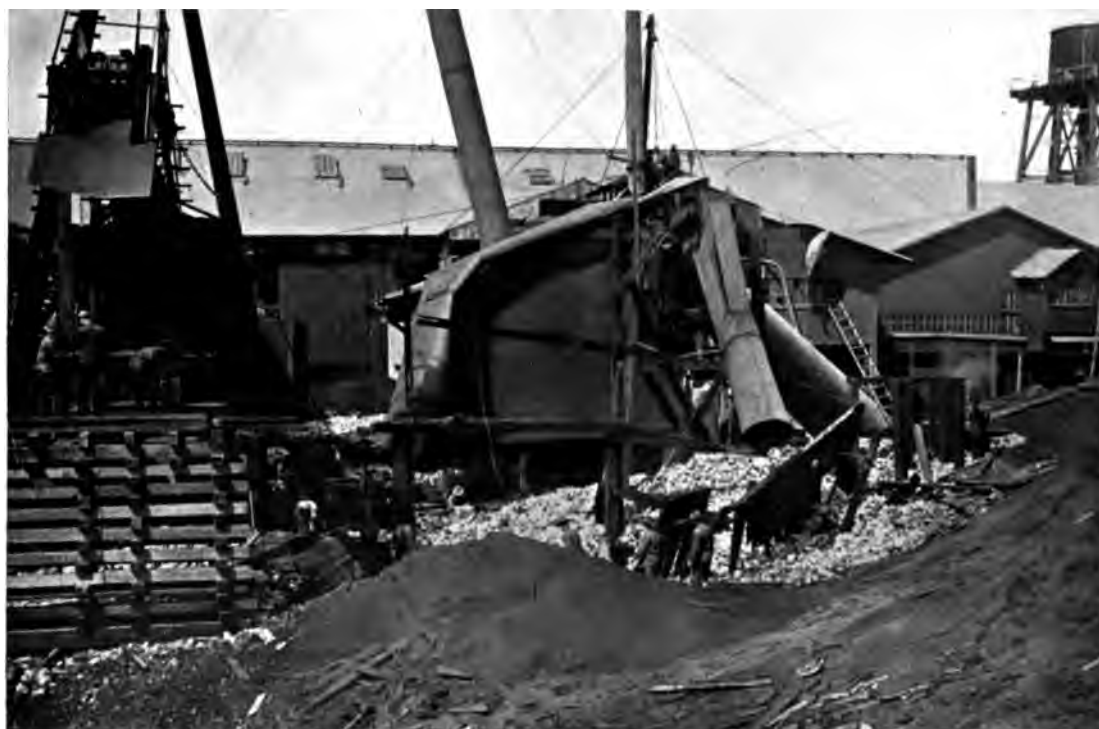
B. U. O. Co.'s mill, Fort Bragg. Smoke stack 5 feet in diameter. Entire structure thrown out of plumb to south, 1 foot in 20 feet.

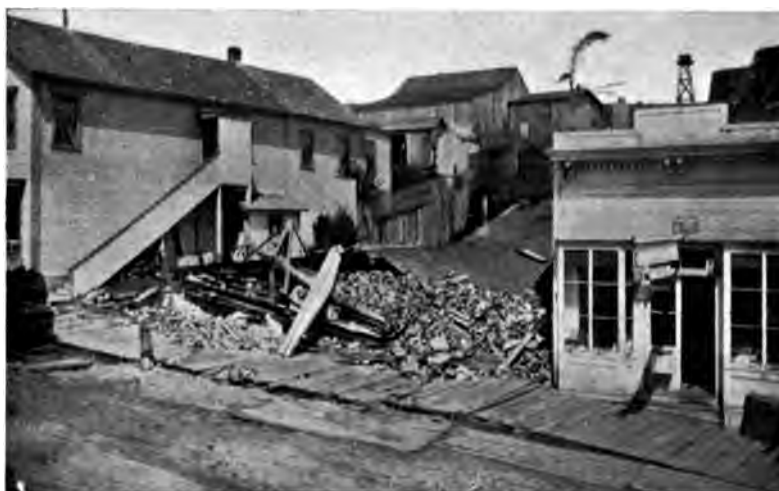
A. Point Arena. Brick house destroyed; wooden houses little affected. F. E. M.

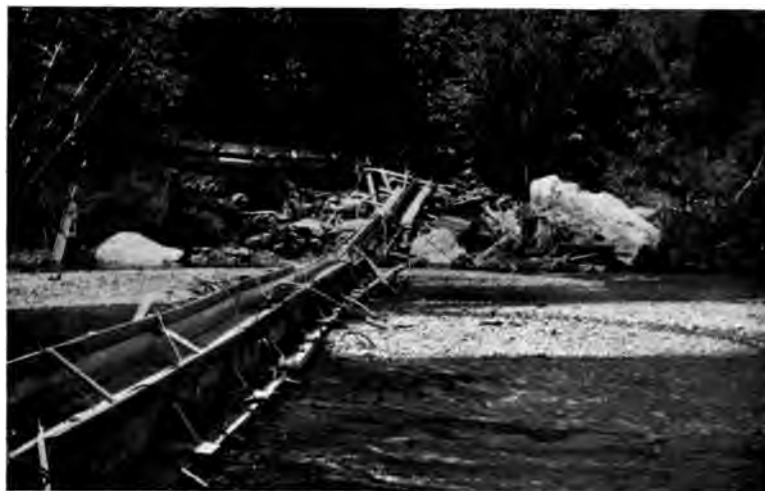
B. Wreck of suspended flume across Garcia River. Looking west. F. E. M.

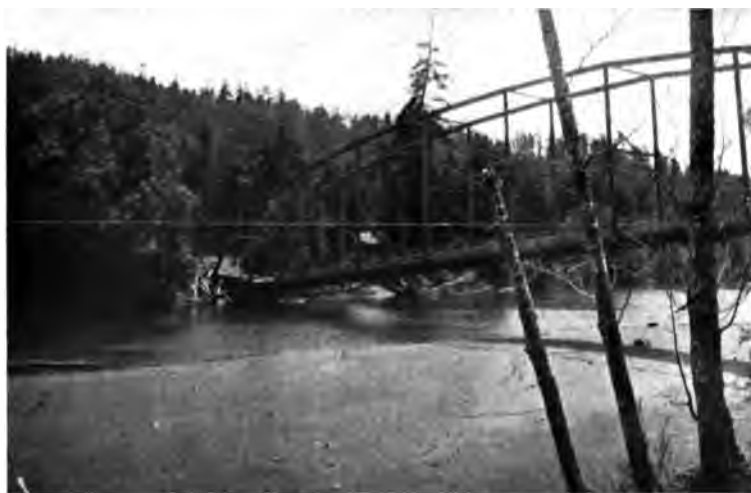
C. Collapsed wagon bridge over Gualala River. South end dropt 20 feet. F. E. M.

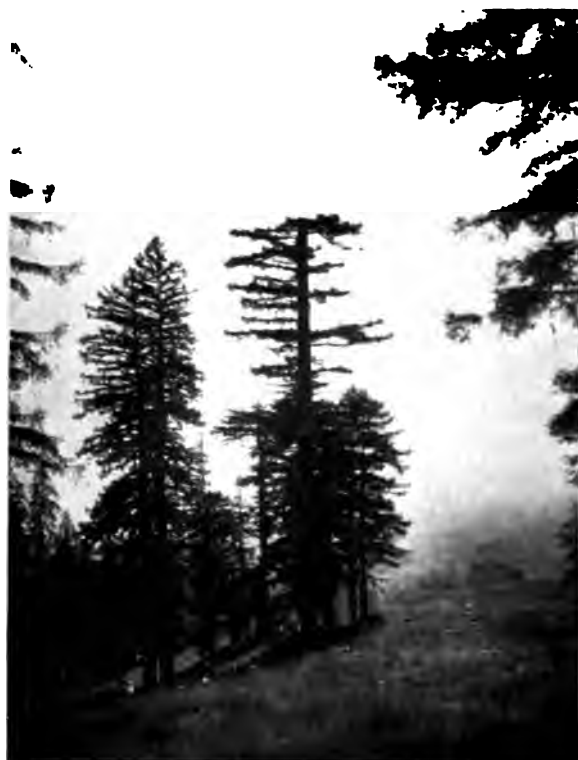
A. Sound redwood tree snapt off 42 feet from top. Near Fort Ross. F. E. M.

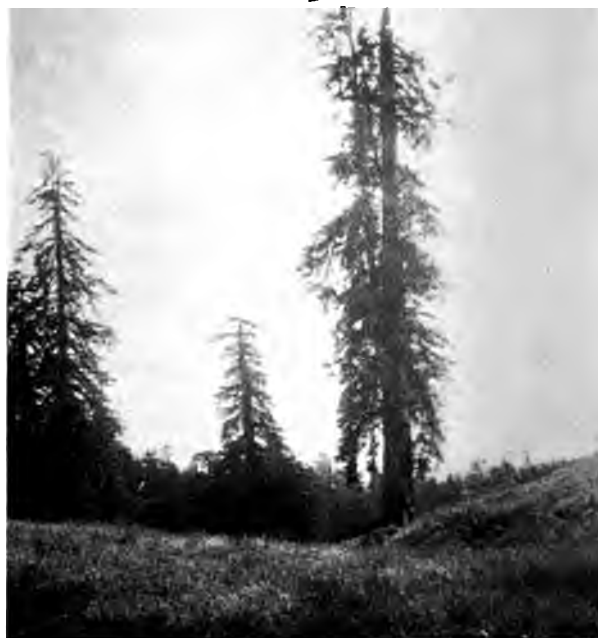
B. Redwood tree snapt off. Locality, 0.25 mile east of fault above Fort Ross. F. E. M.

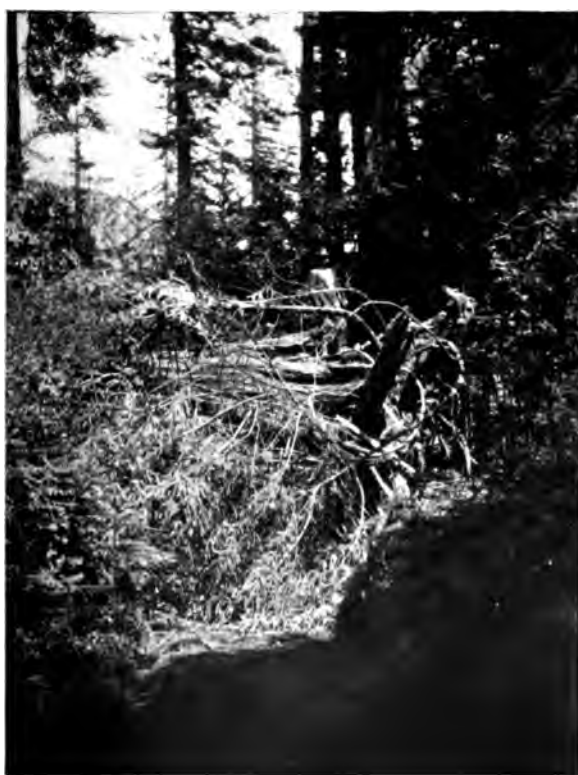
C. Uprooted tree, 8 feet in diameter, 187 feet long, about half mile west of Garcia River, on road to Garcia Mill. Tree sound. F. E. M.

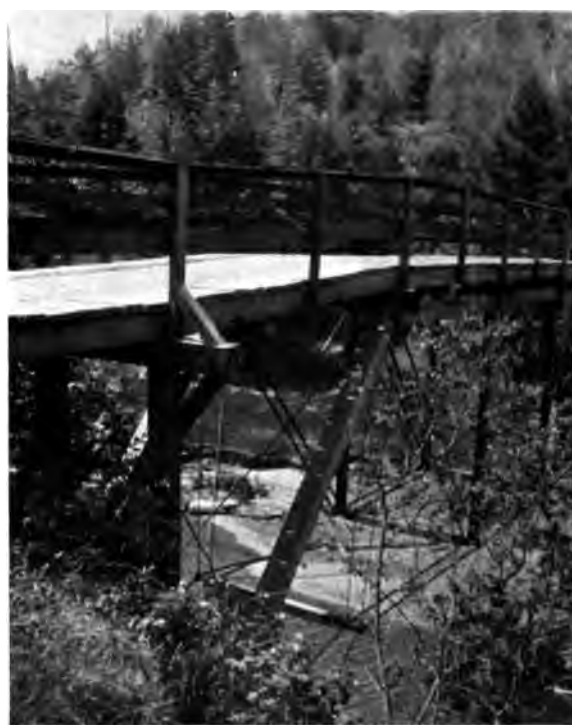
D. Bridge over South Fork, Gualala River, 3 miles east of Stewart's Point, looking north. Bridge floor and panels bent; tension rods buckled. F. E. M.

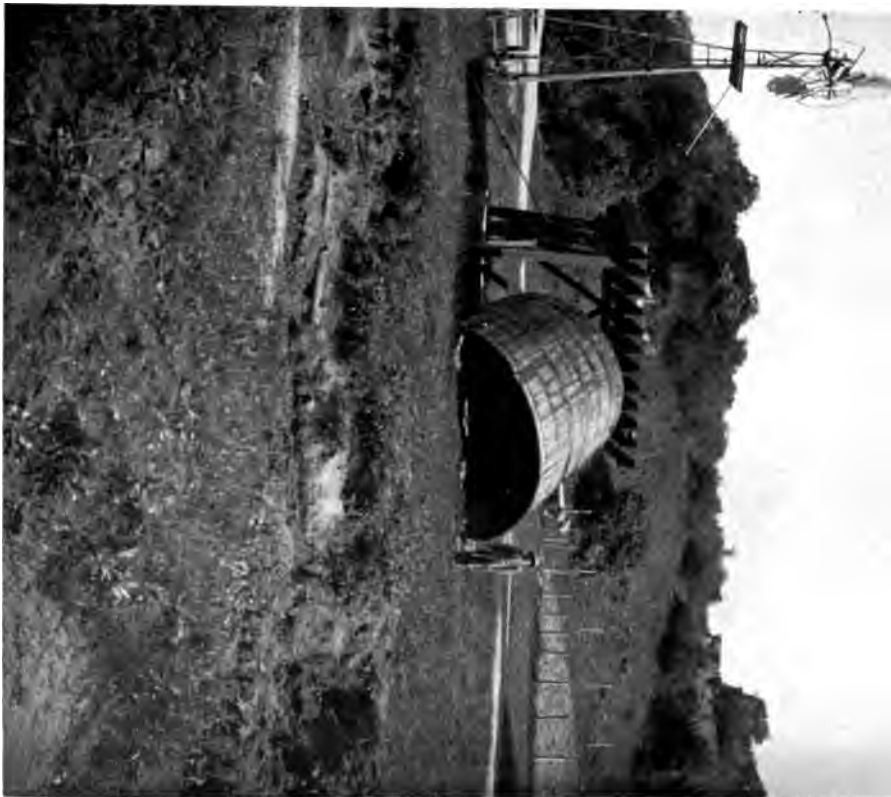
B. Wrecked water-tank, near Inverness. G. K. G.

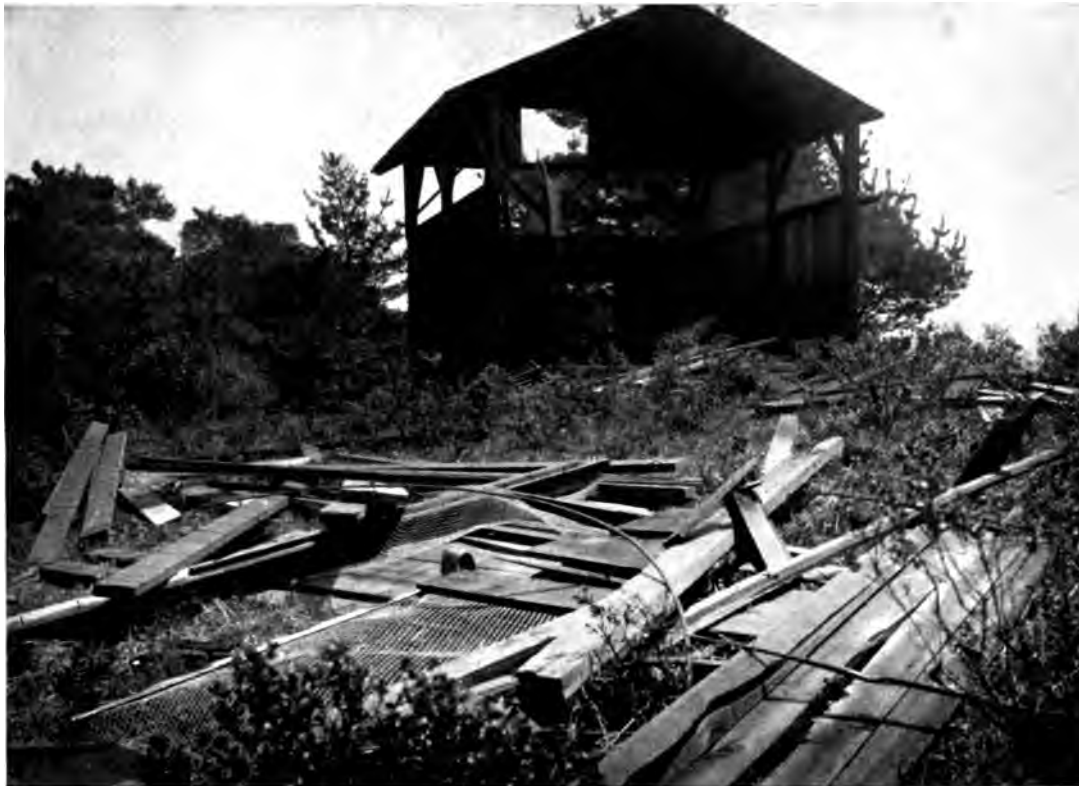
A. Ruin of Inverness reservoir, a circular tank which before earthquake stood in shed. Parts of shed also lie in foreground, about 50 feet from original position. G. K. G.

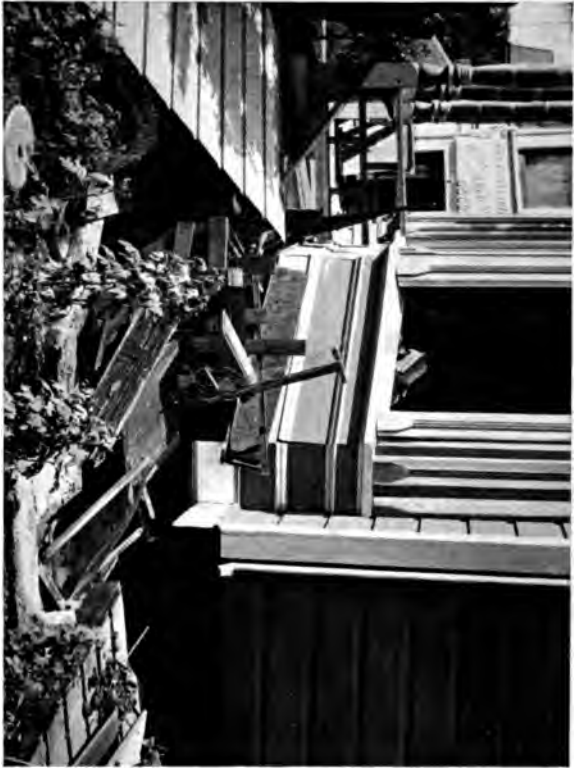
A. House moved 7 feet by collapse of underpinning, Santa Rosa. R. S. H.

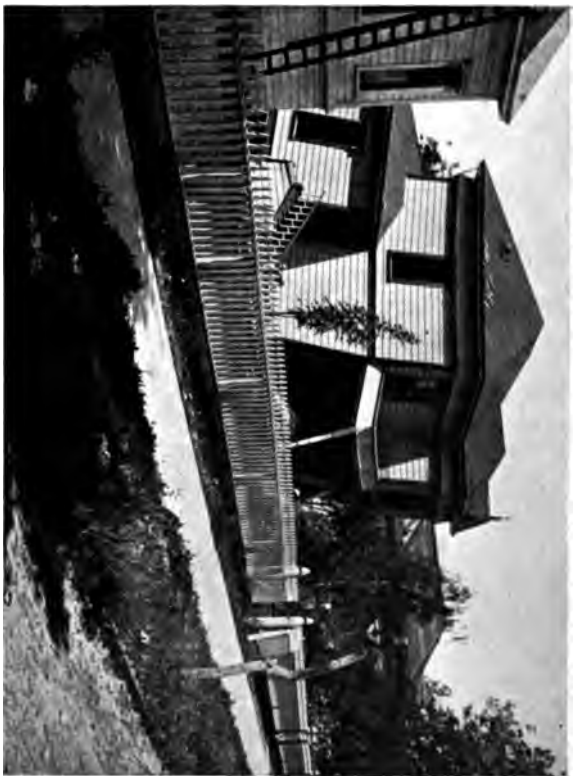
B. House lurched to north, Santa Rosa. R. S. H.

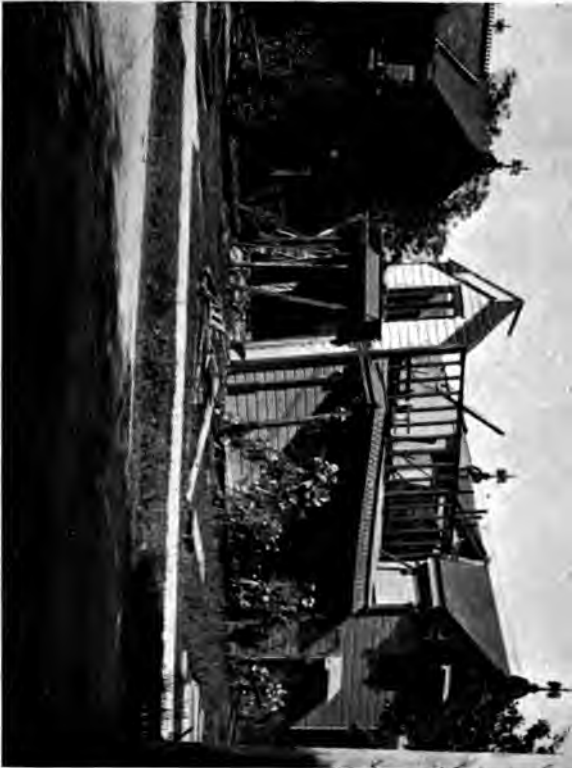
C. Wrecked dwelling, Santa Rosa. R. S. H.

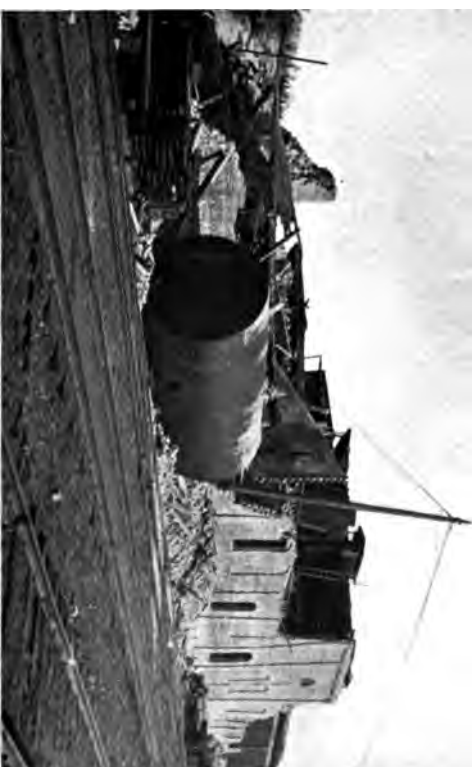
D. Wreck of brick structure, Santa Rosa. R. S. H.

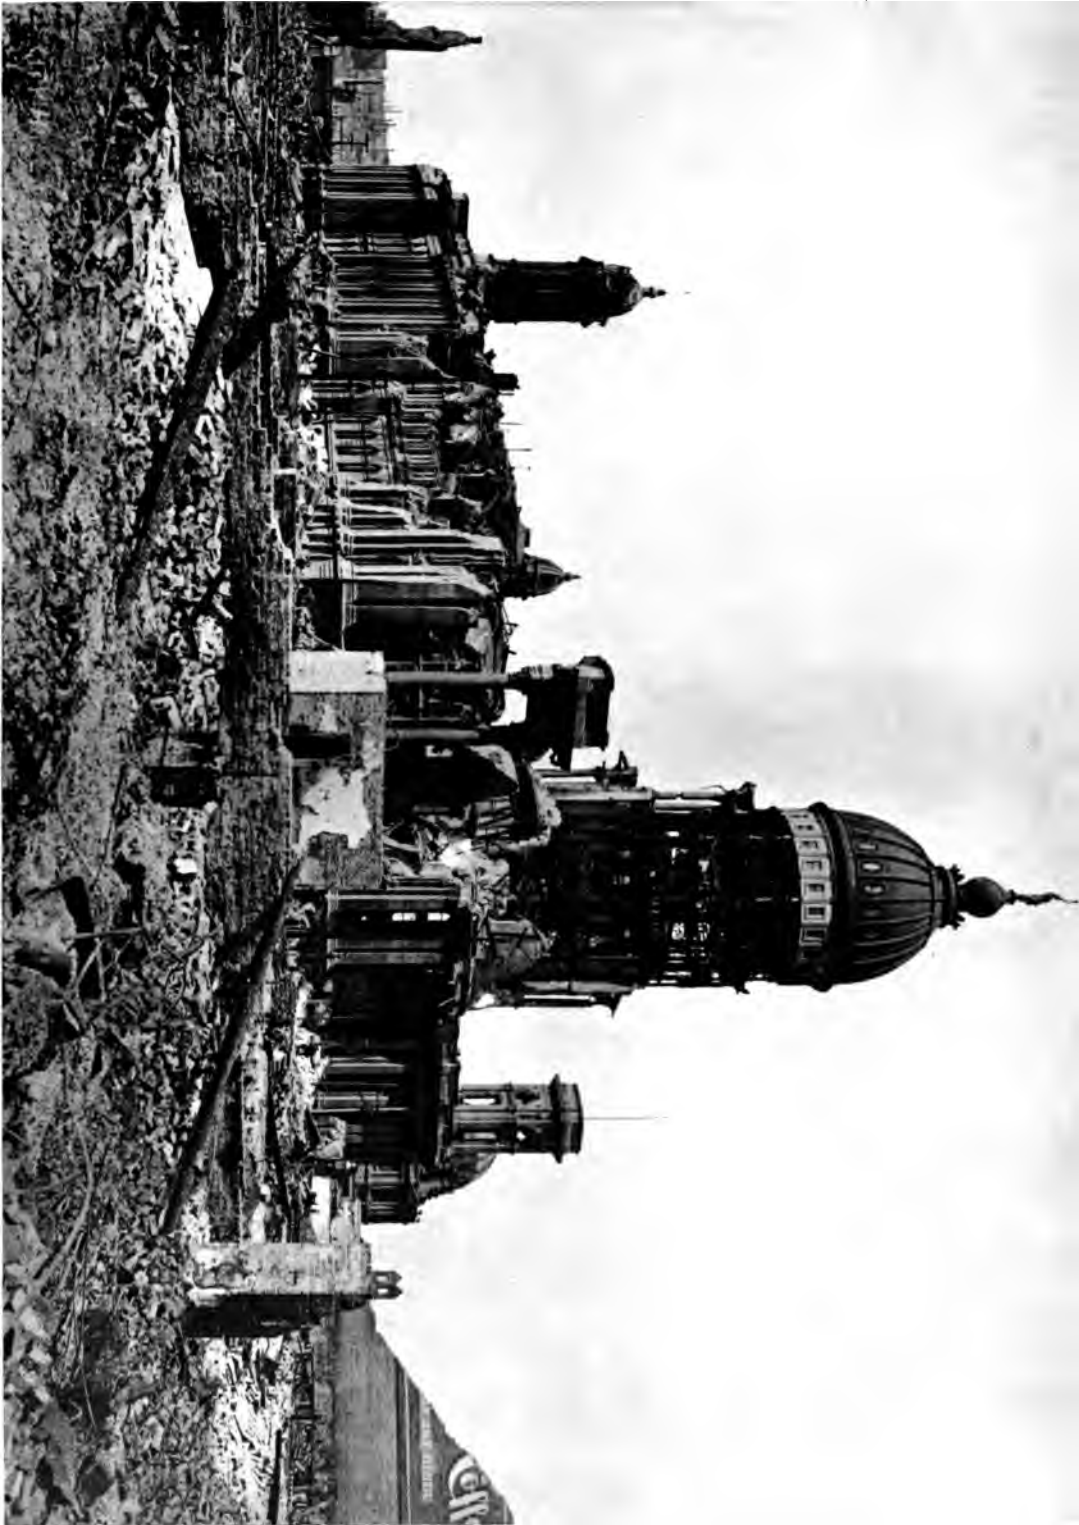
City Hall, San Francisco.

Near the City Hall there was a small locality conspicuous for the damage produced. The City Hall itself made a picturesque ruin (plates 82 and 83A), as all the world knows, but the character of the construction was probably a large factor in its destruction. Nevertheless ugly cracks in other buildings near by indicated intensity somewhat higher than was common in the valley district as a whole.

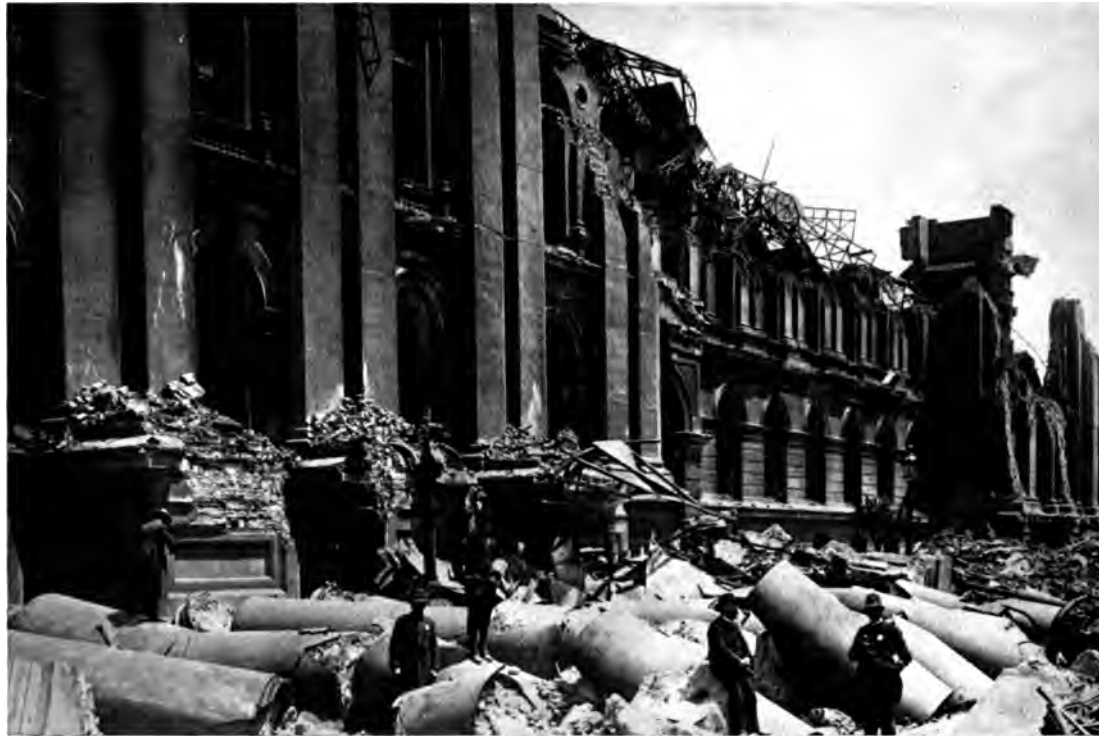
A. A near view of the wreck at the City Hall, San Francisco.
